Vail Home and Condo Inspections

09:25AM August 09, 2009

Photo Attachments

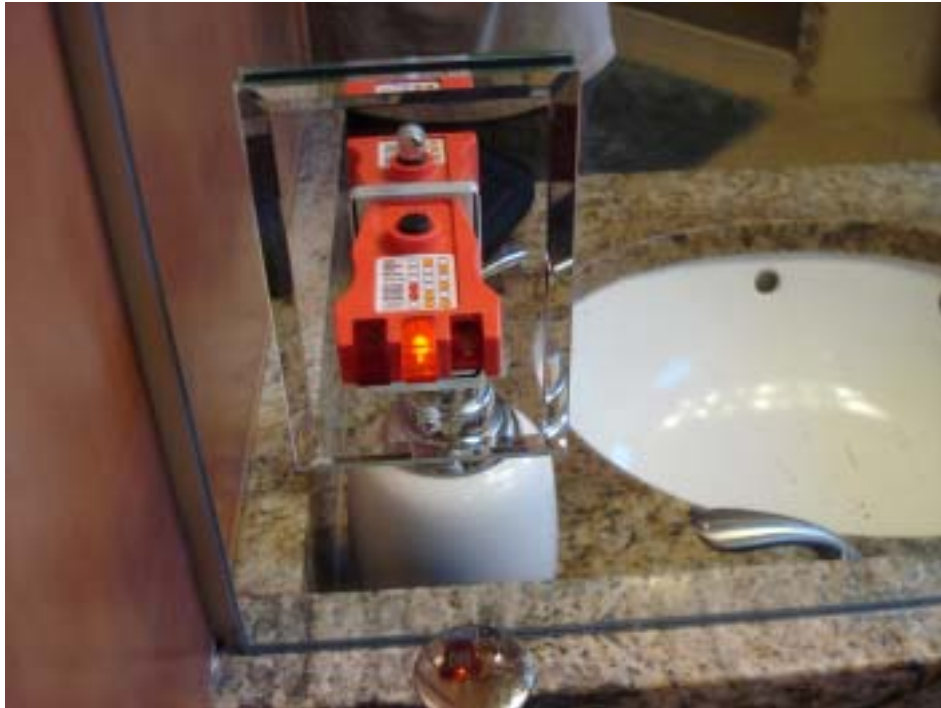
PIC 1: Open ground wire and defective GFI outlet in the master bathroom.

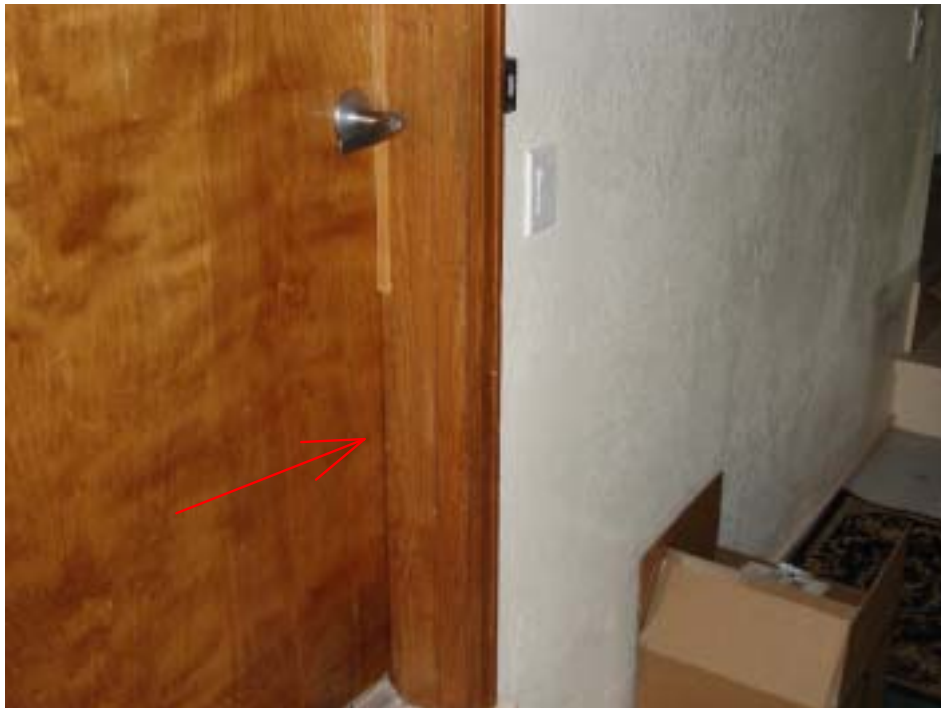
PIC 2: Door from garage to the interior has some damage to the door jam.

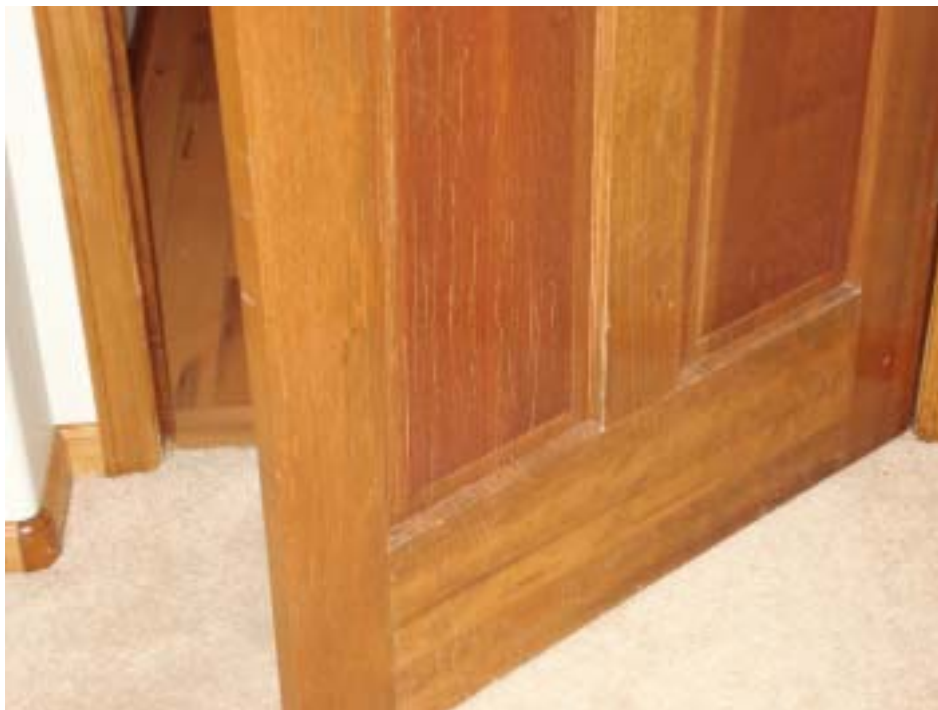
PIC 3: Surface damage to interior door (2nd level west bedroom).

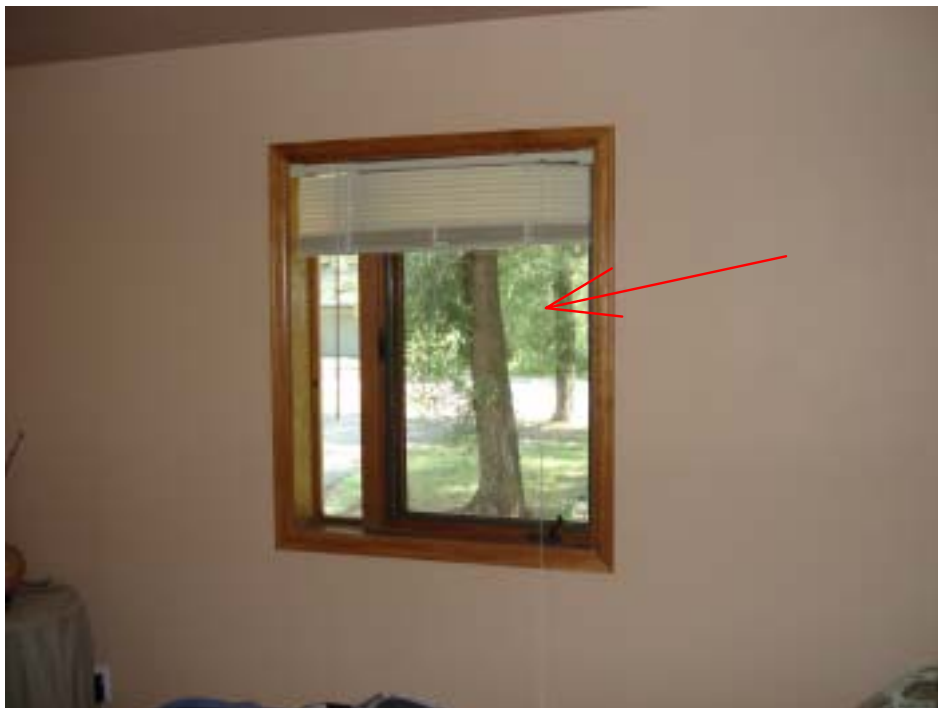
PIC 4: Casement window in the East basement level bedroom does not shut flush to the jam.

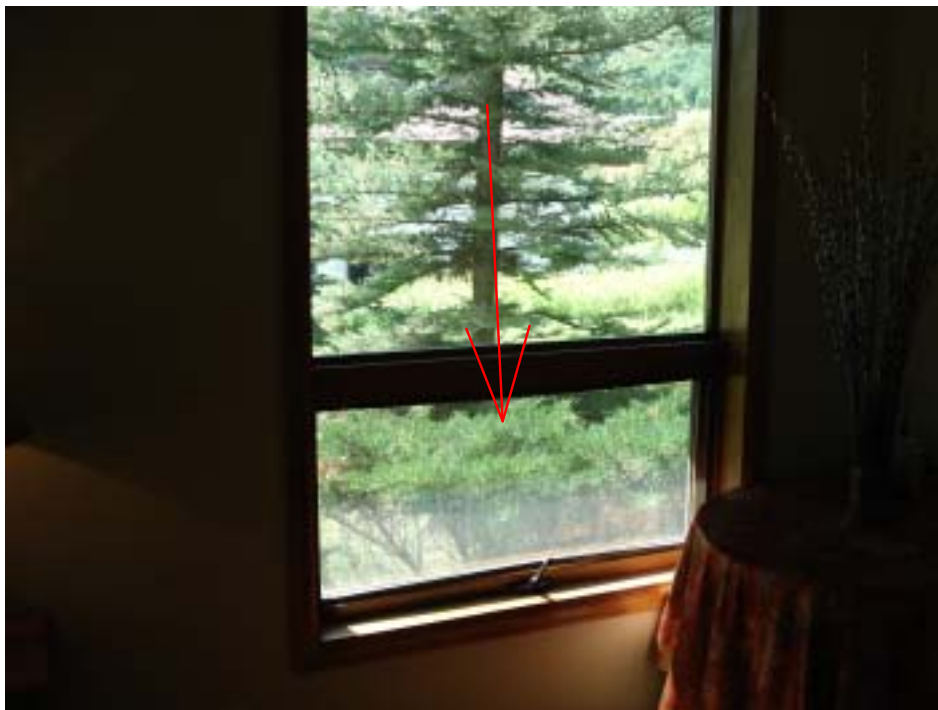
PIC 5: West facing awning window in the basement living room failed to open at the time of the inspection.

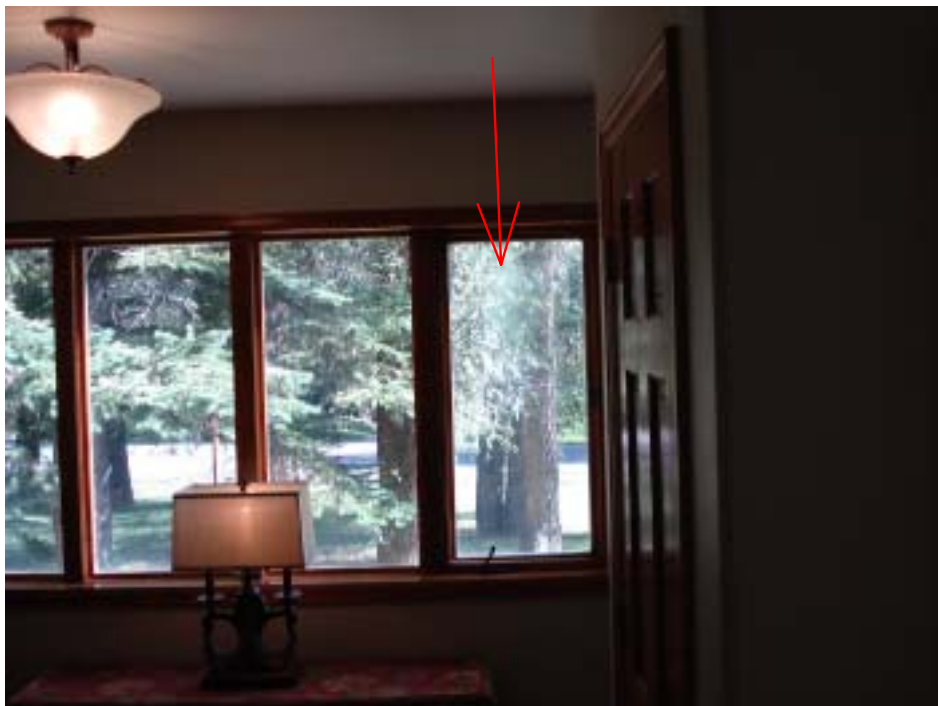
PIC 6: South facing basement casement window appears to have broken seals.

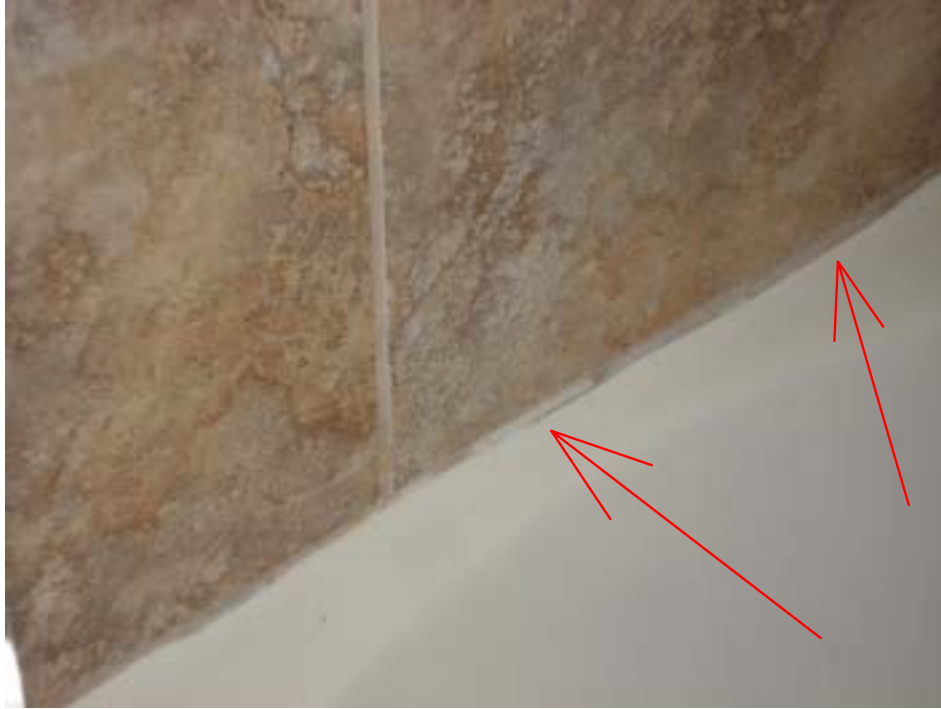
PIC 7: Grout repairs for East 2nd level bathroom room.
