# Quality Home Inspections

## PROPERTY INSPECTION REPORT

Concerning: 2320 Gracy Farms Lane # 713

Inspection Date 09/16/2008

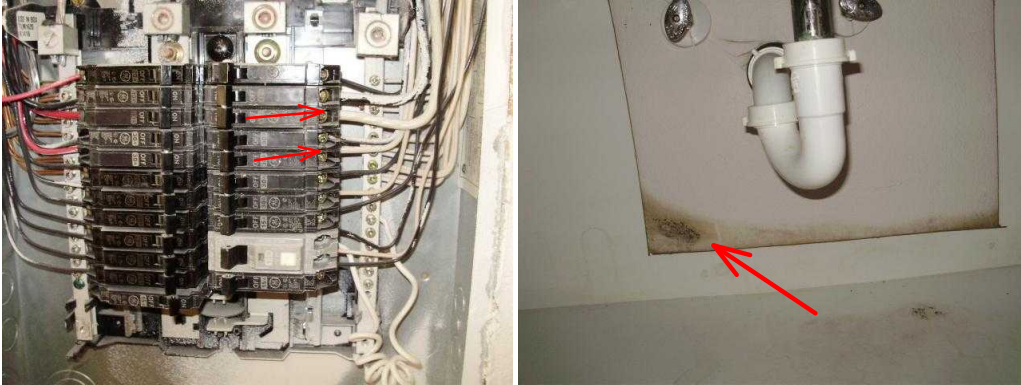
### E. Walls (Interior and Exterior)

Black growth associated with water damage found in hall bathroom sink vanity wall \ cabinet space. This is a common wall and I couldn't determine where the water issue was that caused the staining. Refer to a plumbing contractor

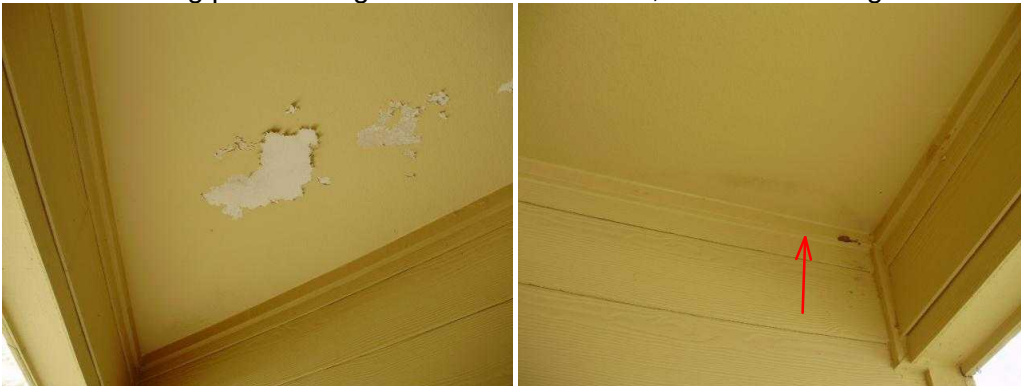
### F. Ceilings and Floors

Patio ceiling paint flaking off and water stained, check for leakage from unit patio above this unit

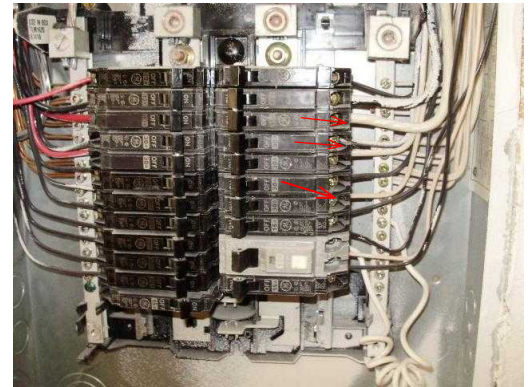
### A. Svc Entrance & Panels

White wires in the electrical panel used as hot conductors at the 240 circuits are not properly taped with red tape

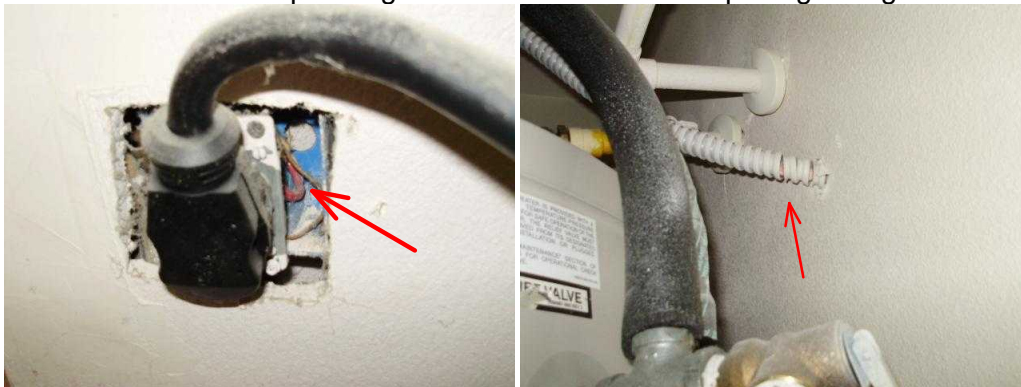
Flexible conduit separating at water heater circuit exposing wiring cable
