SUMMARY REPORT

Doc #: 20120114868B
Dwelling Address: 870 Youngs Road
Southern Pines, NC 28387

AmeriSpec Home Inspection Service

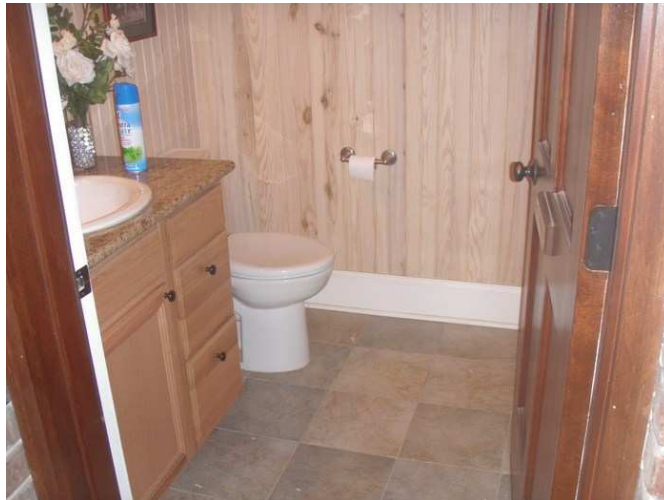
Half Bath- Horse Farm

Step #	Component	Comment
2401.	Floor	Functioning as intended at the time of inspection.
2402.	Walls	Functioning as intended at the time of inspection. Wood.
2403.	Ceiling	Functioning as intended at the time of inspection. Drywall.
2404.	Doors	Functioning as intended at the time of inspection. Wood.
2407.	Heat / Cooling Source	Central heating/cooling.
2408.	Electrical	Functioning as intended at the time of inspection. Ground fault interrupter provided for safety.
2409.	Exhaust Fan	Functioning as intended at the time of inspection.
2410.	Sinks	Functioning as intended at the time of inspection.
2411.	Sink Faucets	Functioning as intended at the time of inspection.
2412.	Traps / Drains / Supply	Functioning as intended at the time of inspection.
2413.	Toilet	Functioning as intended at the time of inspection.
2415.	Counter / Cabinets	Functioning as intended at the time of inspection. Polished granite.

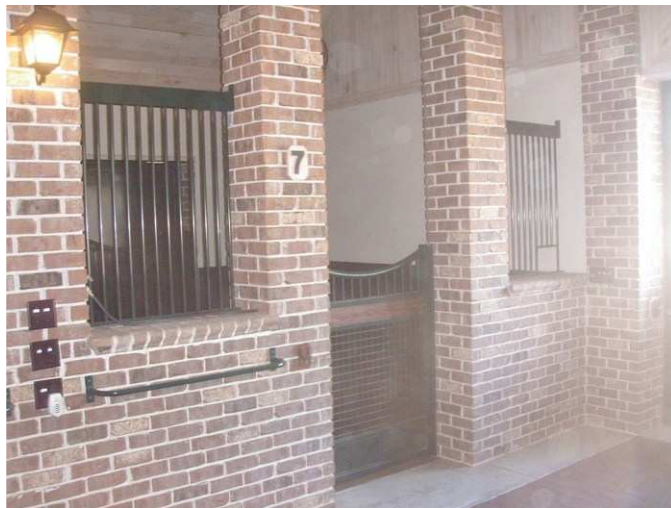
One Of Eight Horse Stalls

- 2627. Heat / Cooling Source Central heating/cooling.
- 2628. Electrical
- 2630. Maintenance Functioning as intended at the time of inspection. Fly spray system present at the ceiling. Eight horse stalls. Each horse stall is 14 feet by 12 feet.
