AmeriSpec Home Inspections
7363 Fire Department Road
Hope Mills, NC 28348
Ph#: (910)426-4747 Fax#: (910)423-0108

Doc #: 20120114868
Dwelling Address: 870 Youngs Road
Southern Pines, NC 28387

Guest House

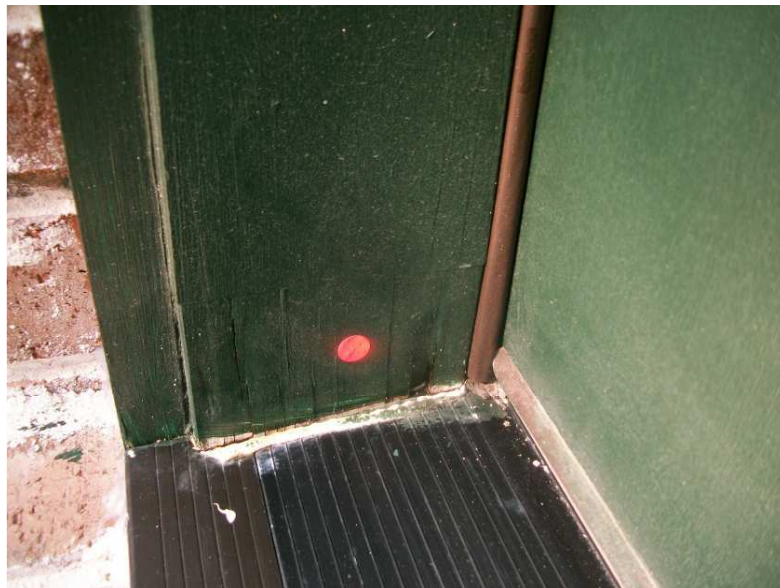
1106. Exterior Door(s)

**Review. Damaged casing noted at the second floor entry door.
Recommend repair by a qualified contractor.**

Door casing at the second floor entry door.

| Step # | Component | Comment |
|---|---|---|
| 1106. | Exterior Door(s) | Review. Wood, Metal clad. Damaged casing noted at the second floor entry door. Recommend repair by a qualified contractor. |

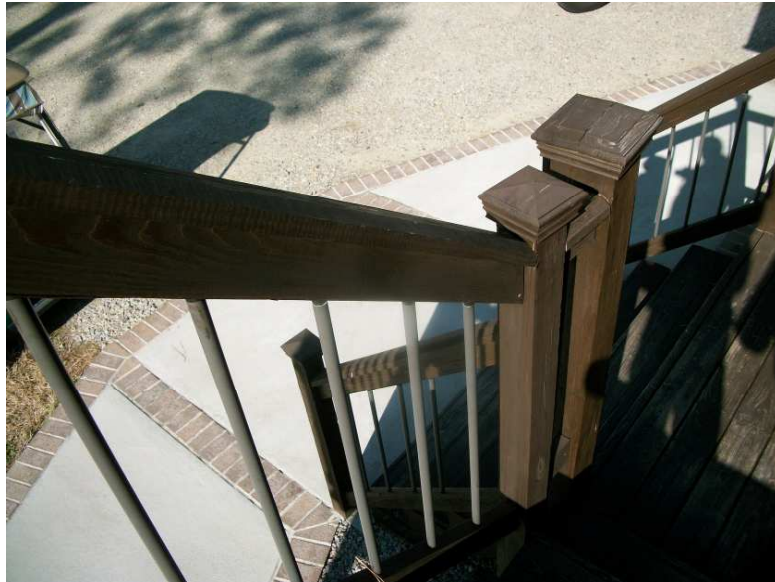
1122. Stairs / Steps

Review. Loose rails and damaged post caps noted at the stairs and rails leading to the second floor. Recommend repair by a qualified contractor.

Damaged post caps noted at the exterior stairs.

| 1122. | Stairs / Steps | Review. Wood. Loose rails and damaged post caps noted at the stairs and rails leading to the second floor. Recommend repair by a qualified contractor. |

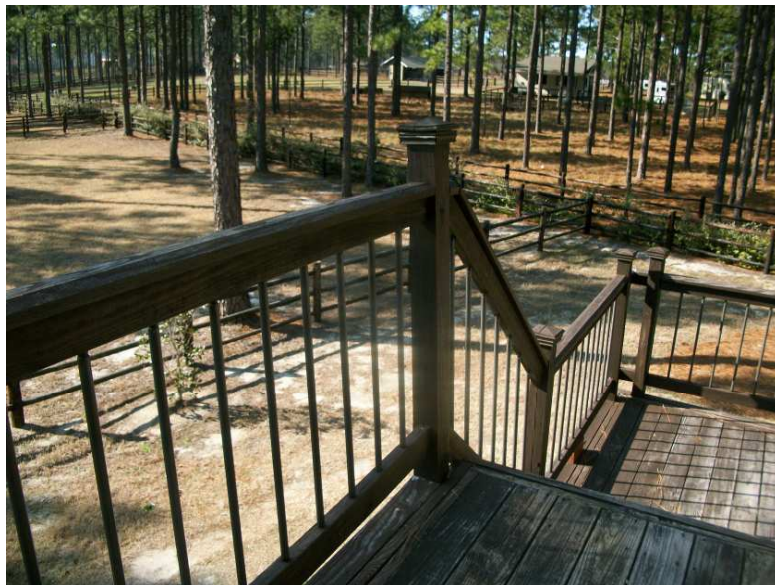
Loose handrails noted at the exterior stairs.
