**AmeriSpec Home Inspections**  
**7363 Fire Department Road**  
**Hope Mills, NC 28348**  
**Ph#: (910)426-4747 Fax#: (910)423-0108**

Doc #: 20120114868  
Dwelling Address: 870 Youngs Road  
Southern Pines, NC 28387

Doc #: 20120114868 Inspector: Arnold McLaurin #217  
Date: 1/4/2012  
Dwelling Address: 870 Youngs Road  
Southern Pines, NC 28387  
Client Name: Mike  
Client's Agent: N/A Real Estate Company: N/A

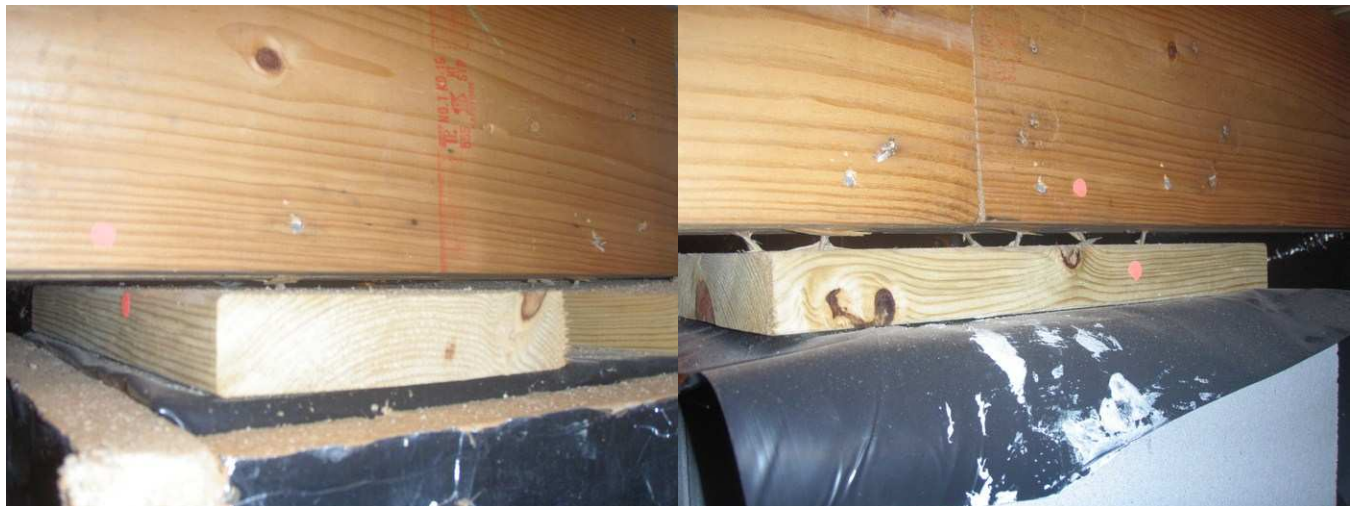
**Review. Piers at the left front crawlspace are not shimmed properly to the floor system. Recommend correction by a qualified contractor.**

1505.	Sub Floor	Functioning as intended at the time of inspection. Oriented Strand Board.
1506.	Support Posts / Columns	<b>Review. Concrete blocks. Piers at the left front crawlspace are not shimmed properly to the floor system. Recommend correction by a qualified contractor.</b>
1507.	Beams	Functioning as intended at the time of inspection. Wood.
1508.	Electrical	Functioning as intended at the time of inspection.
1509.	Ventilation	Functioning as intended at the time of inspection. This is a sealed conditioned crawlspace.
1510.	Insulation	Functioning as intended at the time of inspection. Foundation walls are insulated.
1512.	Distribution / Ducting	Functioning as intended at the time of inspection. Flex Ducts/Registers.
1515.	Visible Plumbing	Functioning as intended at the time of inspection. Pex. Plastic
1518.	Crawlspace Comments	Functioning as intended at the time of inspection.

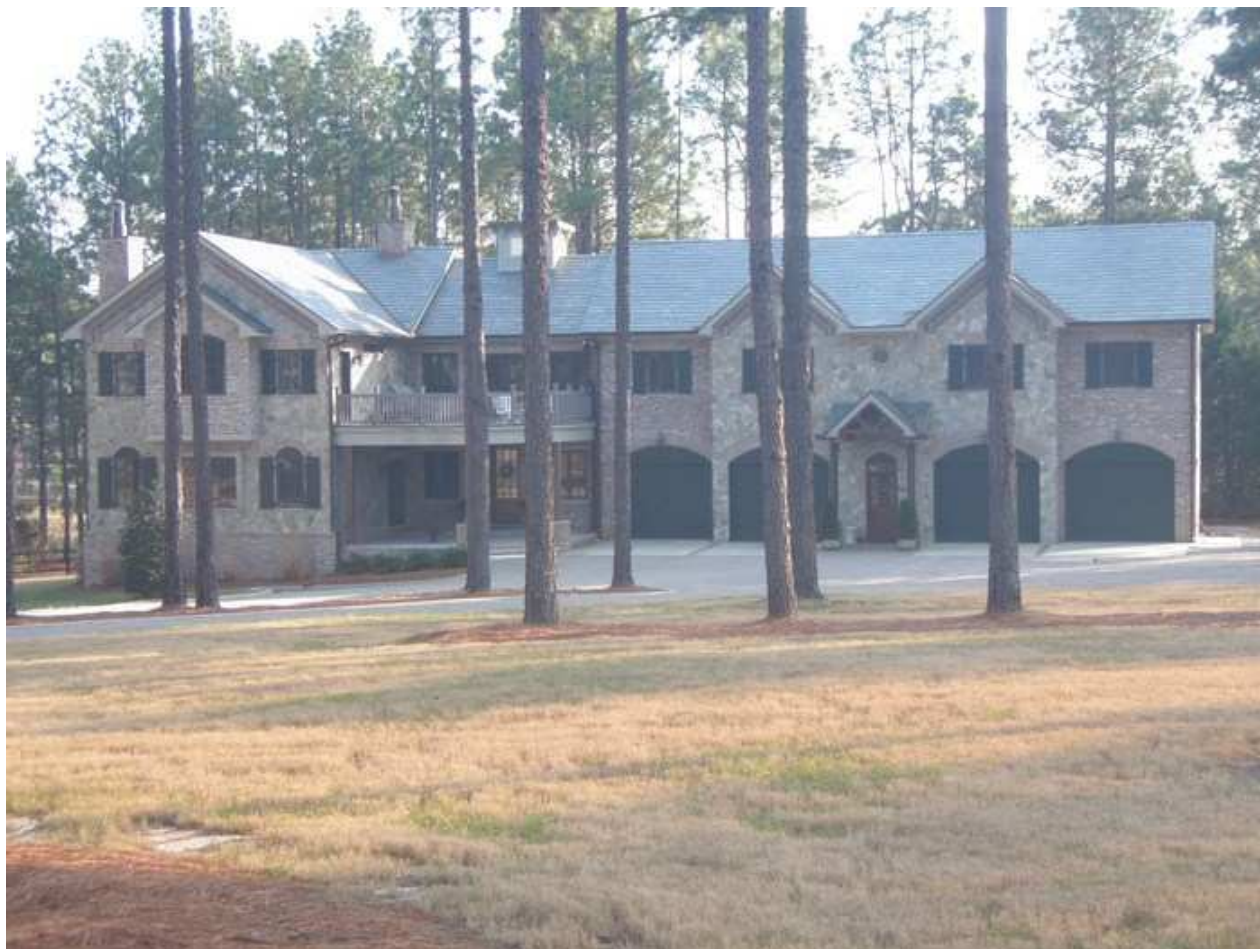
Front view of the main house

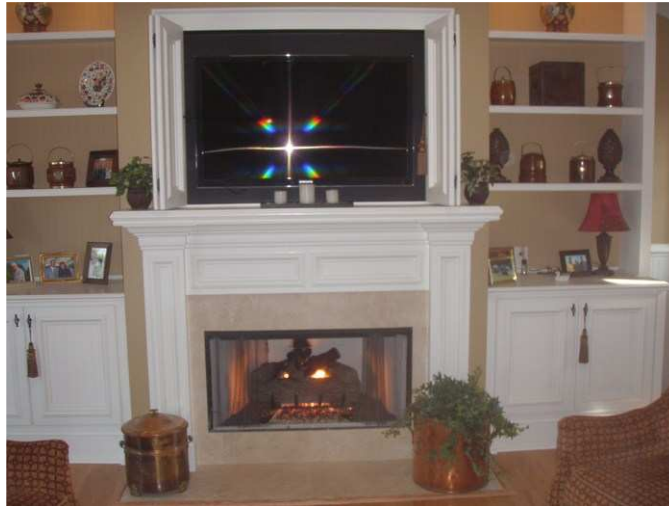
1409. Fireplace Functioning as intended at the time of inspection. Gas log.

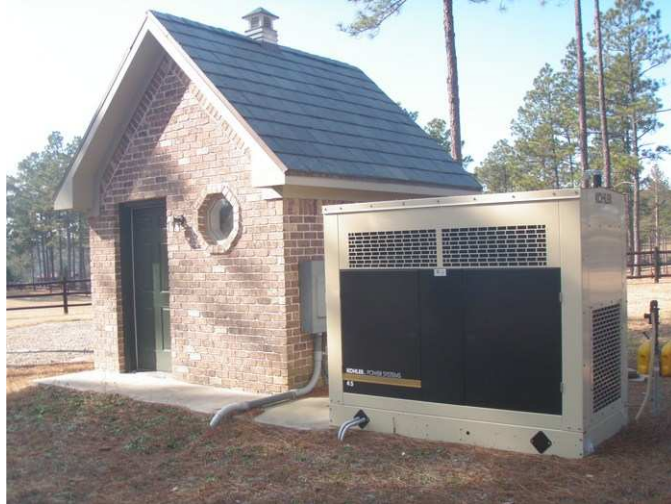
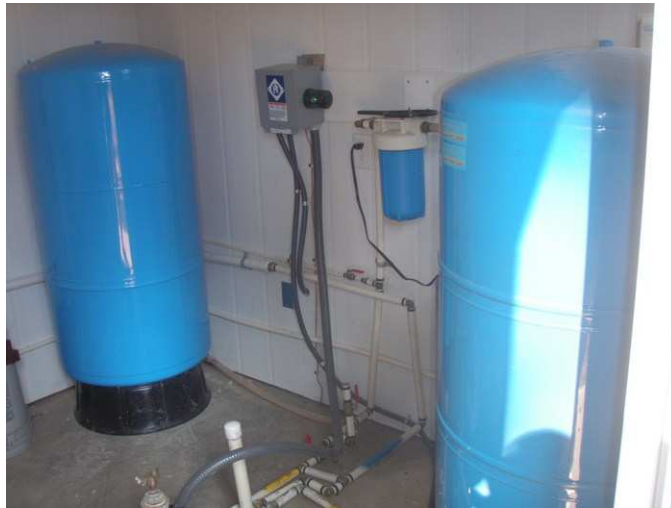
- 1709. Plumbing Comments  
Functioning as intended at the time of inspection. Pump house located across the pond from the horse barn.

Step #	Component	Comment
1801.	Electrical Main Service	Functioning as intended at the time of inspection. Service entrance is underground. A main disconnect has been provided at the main panel.
1802.	Main Electrical Panel & Location	Functioning as intended at the time of inspection. Service entrance cables are aluminum; Branch circuit wiring is copper. The main electrical panel is located in Exterior wall. Overload protection provided by breakers.
1803.	Wiring Method	Functioning as intended at the time of inspection. Romex.
1804.	Sub-Panel Comments & Location	Functioning as intended at the time of inspection. The sub-panel(s) is located in garage.
1805.	Smoke Detectors	Functioning as intended at the time of inspection. Tested OK. Periodic testing is suggested to ensure proper working order.
1806.	Service Amperage and Voltage	120 & 240 volts. Electrical service is approximately 200 amps.
1808.	Electrical Comments	Generator present. Located beside the pump house. Shown in photo on page 11.

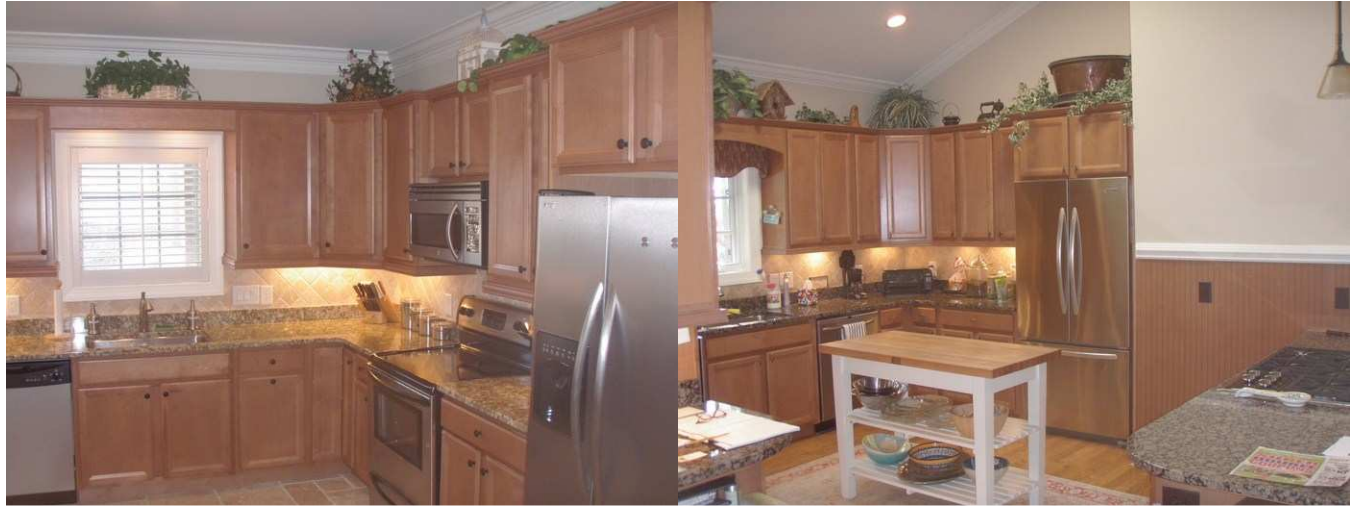
### Kitchen

Step #	Component	Comment
2201.	Floor	Functioning as intended at the time of inspection. Wood.
2202.	Walls	Functioning as intended at the time of inspection. Drywall; Wood.
2203.	Ceiling	Functioning as intended at the time of inspection. Drywall; Wood.
2206.	Windows	Functioning as intended at the time of inspection. Louvered. Thermopane windows observed in the home. The inspector is unable to determine if all double glazed insulated windows in this property are completely intact and without compromised seals. Conditions indicating a broken seal are not always visible or present and may not be apparent or visible at the time of inspection. Changing conditions such as temperature, humidity, and lighting limit the ability of the inspector to visually review these windows for broken seals. For more complete information on the condition of all double glazed windows, consult the seller prior to closing.

2207.	Heat / Cooling Source	Central heating/cooling.
2208.	Electrical	Functioning as intended at the time of inspection. Ground fault interrupter provided for safety.
2209.	Cabinets	Functioning as intended at the time of inspection.
2210.	Counter Tops	Functioning as intended at the time of inspection. Granite.
2211.	Sinks	Functioning as intended at the time of inspection. Stainless steel.
2212.	Faucets	Functioning as intended at the time of inspection.
2213.	Traps / Drains / Supply	Functioning as intended at the time of inspection.
2214.	Disposals	Functioning as intended at the time of inspection.
2215.	Dishwasher(s)	Functioning as intended at the time of inspection.
2217.	Stove / Cook Top	Functioning as intended at the time of inspection. The gas stove/range was tested at the time of inspection and functioned properly.

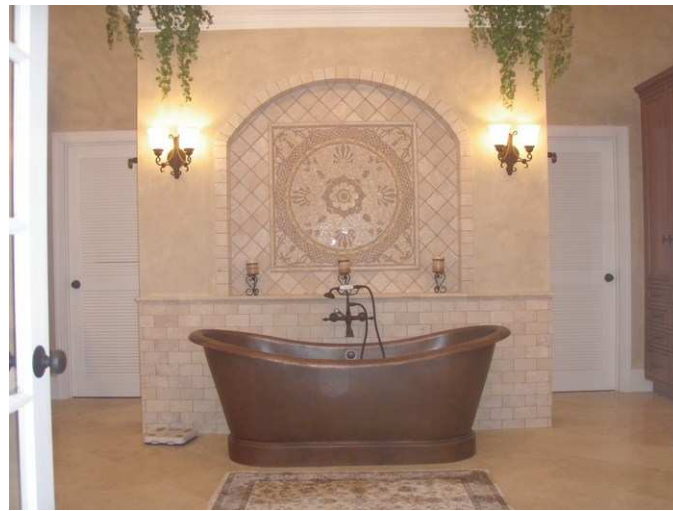
### Bathroom -Master Bath

Step #	Component	Comment
2301.	Floor	Functioning as intended at the time of inspection. Tile.
2302.	Walls	Functioning as intended at the time of inspection. Drywall; Tile.
2303.	Ceiling	Functioning as intended at the time of inspection. Drywall.
2304.	Doors	Functioning as intended at the time of inspection. Wood.
2305.	Closet / Wardrobe	Functioning as intended at the time of inspection. Wood. Separate closets for husband and wife.
2307.	Heat / Cooling Source	Central heating/cooling.
2308.	Electrical	Functioning as intended at the time of inspection. Ground fault interrupter provided for safety.
2309.	Exhaust Fan	Functioning as intended at the time of inspection.
2310.	Tub/Whirlpool	Functioning as intended at the time of inspection. Tub. Free standing tub is copper.
2313.	Tub Faucet	Functioning as intended at the time of inspection.
2314.	Shower Base	Functioning as intended at the time of inspection. Ceramic tile.

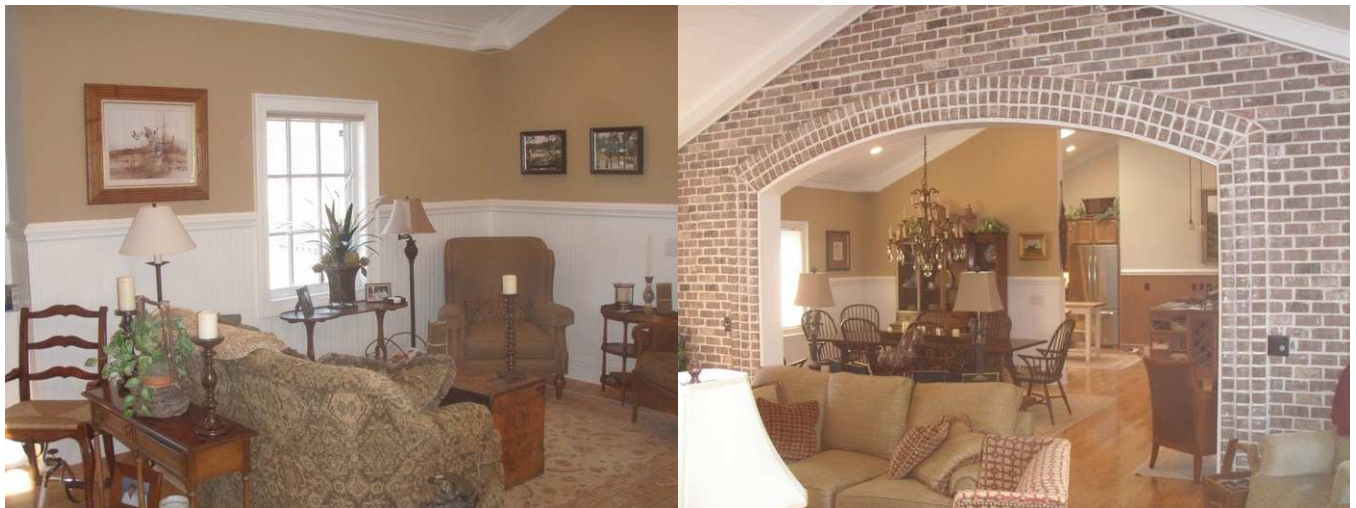
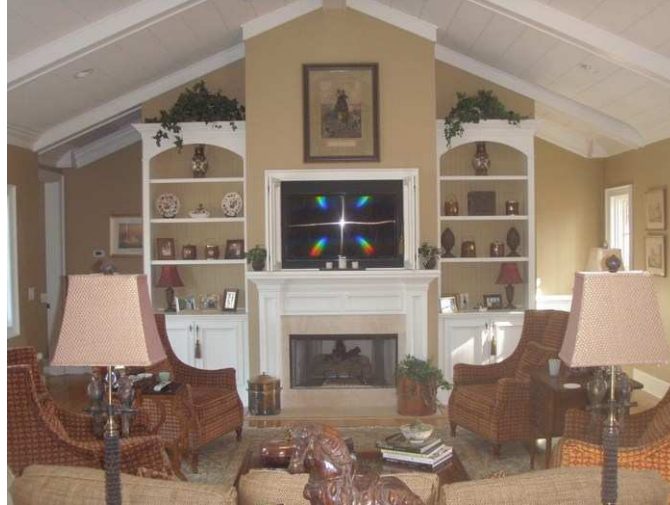
### Interior Rooms / Hallways / Stairs

Step #	Component	Comment
2621.	Floors	Functioning as intended at the time of inspection. Carpet; Tile; Wood.
2622.	Walls	Functioning as intended at the time of inspection. Brick; Drywall; Wood; Brick columns.
2623.	Ceilings	Functioning as intended at the time of inspection. Drywall; Wood.
2624.	Doors	Functioning as intended at the time of inspection. Wood.
2625.	Closets	Functioning as intended at the time of inspection. Wood.
2626.	Windows	Functioning as intended at the time of inspection. Vinyl frame; Louvered. Double glazed insulated windows observed in the home. The inspector is unable to determine if all double glazed insulated windows in this property are completely intact and without compromised seals. Conditions indicating a broken seal are not always visible or present and may not be apparent or visible at the time of inspection. Changing conditions such as temperature, humidity, and lighting limit the ability of the inspector to visually review these windows for broken seals. For more complete information on the condition of all double glazed windows, consult the seller prior to closing.
