PROPERTY INSPECTION REPORT

Concerning: 12166 Metric Boulevard #351

City Austin State Texas Zip 78758

Inspection Date 09/16/2008

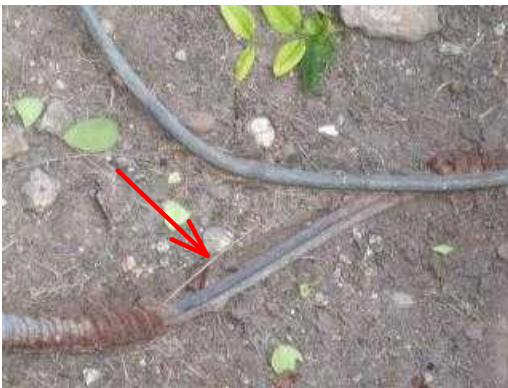
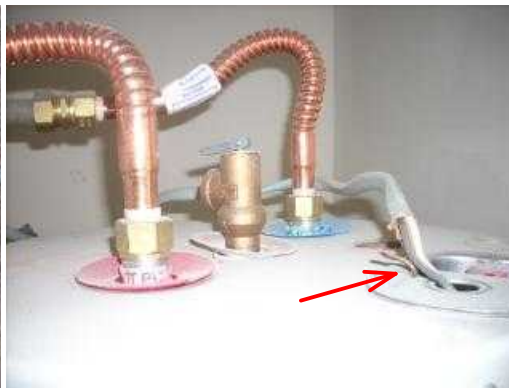
B. Branch Circuits B. Branch Circuits - Connected Devices and Fixtures (Report as in need of repair the lack of ground fault circuit protection where required.):

Kitchen counter outlets and outlet located at bar area on the backside of the sink are not gfci protected.
Bulb guards missing on utility room and exterior storage light fixtures.
Electrical supply to disposal and water heater are not properly protected with a wire clamp or grommet where they enter the units.
One wall switch in living area controls the bottom receptacle of outlet to the left of the fireplace.
Damaged conduit on electrical supply to exterior a/c unit with exposed wires.

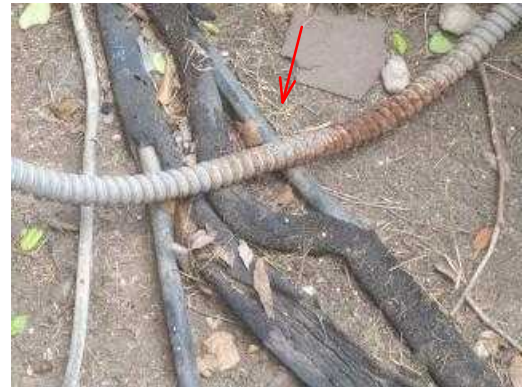
B. Cooling Equipment B. Cooling Equipment

In wall plenum unit.

Interior unit appears to be original with possible newer cooling coil.
Coil is clean.

Unit had an acceptable temperature differential across the coil.
Exterior unit is newer and shows to be a 1998 model. The unit is not elevated 3" and shows to have areas of corrosion around the bottom of its housing. Damaged and missing insulation on low pressure line.

Recommend routine evaluation, servicing and cleaning of the system by a qualified HVAC contractor.

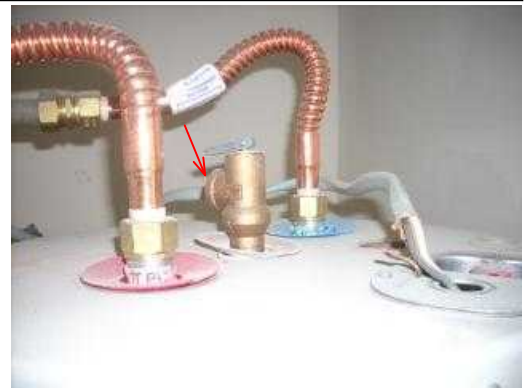
C. Water Heater C. Water Heating Equipment (Report as in need of repair those conditions specifically listed as recognized hazards by TREC rules)

2006 model.

Does not have a drip pan with an exterior drain line installed.

TPR valve does not have a drain line installed.

Electrical supply is not properly protected where it enters the unit and does not have an electrical disconnect at the unit.

Water lines should be insulated.
