# Beaches Inspection Services

## CONFIDENTIAL INSPECTION REPORT

683 Queen's Harbor Blvd., Jacksonville, FL

5/2/2007 9:00 am to 12:00 pm

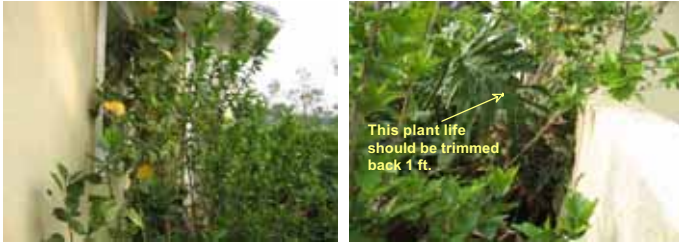
Vegetation is encroaching on the structure, and should be kept a minimum of twelve inches away for the general welfare of the walls and foundation. This also will help detect nesting and tunneling of insects.

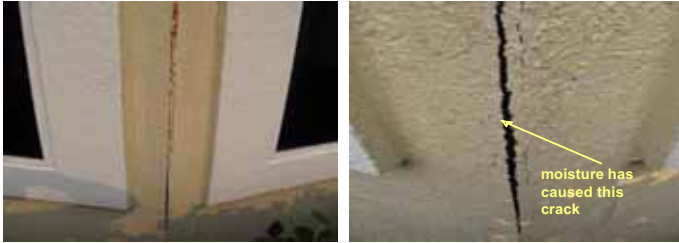
There is a non-typical stress fracture in the stucco that has been examined by a specialist. This crack was caused by moisture penetrating the building, most likely at that point of entry. The repair cost has been determined by the contractor and the damage has been deemed minor and non-structural. According to the contractor, this rules out any possibility of latent structural damage. This analysis supersedes any and all observations made by our inspection service and any future repairs should be in accordance with the contractor's recommendations.

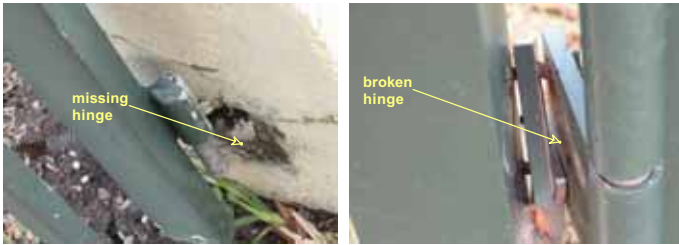
The gates needs typical maintenance & repair-type service, to open and close or latch easily.

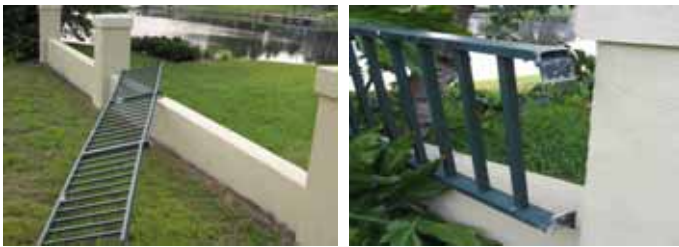
Sections of the fence are broken or damaged and should be repaired or replaced.

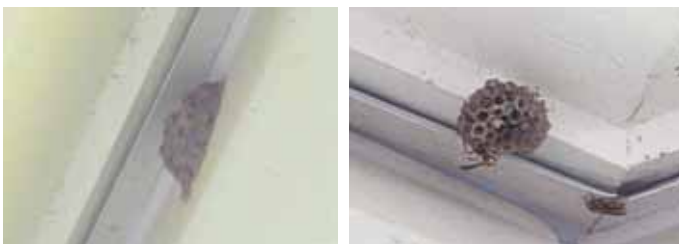
Sections of the soffit have some mud dopples or bee nests attached to the underside. These should be removed to deter further growth.

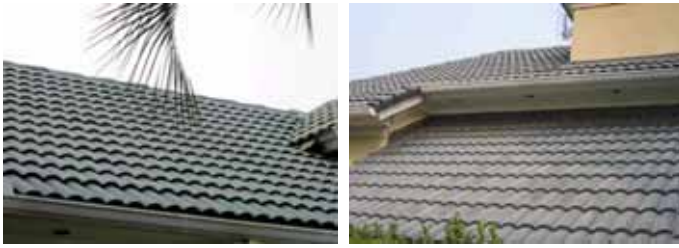
The roof appears to be the same age as the residence, or 10 years old.

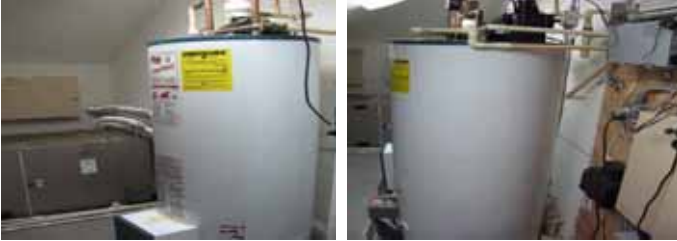
Hot water is provided by two gas water heaters, a 10 year old, 50 gallon unit, located in the primary attic space, and a 10 year old, 65 gallon unit, located in the same space.

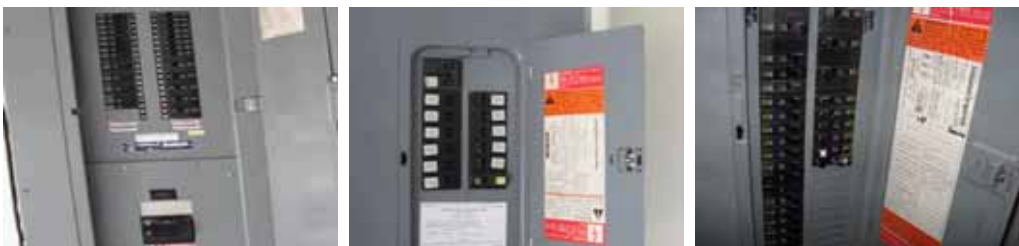
The sub panels are located in the garage and the upstairs attic closet.

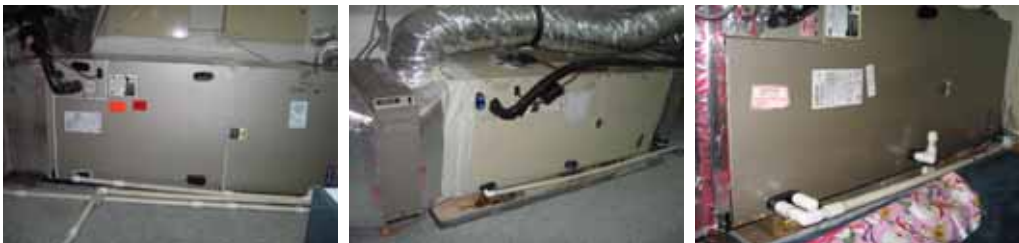
Central heat and air-conditioning are provided by triple systems, consisting of three 10 year-old furnaces with evaporator coils that are located in the attic closet spaces, and three 10 year-old condensing coils that are located on the house side yard.

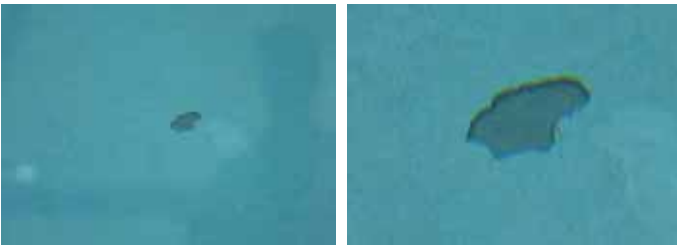
The interior finish is Pebble-tec, which is in acceptable condition, with the exception of one spot in the center bottom, which has some of the finish chipped away leaving a noticeable mark. It does not appear to be leaking water so currently, it is more cosmetic. Pebble-tec is a popular and durable pool finish, because it can be exposed to air, however, to repair this, the pool must be drained first.
