Inspection Summary

Perfection Home Inspections
1042 E. Fairbrook Circle
Mesa, AZ 85203
www.perfectionhomeinspections.com
(480) 833-9330

Record 3503 - Understiller, Roger 2625 N. Val Vista Drive, Mesa, AZ

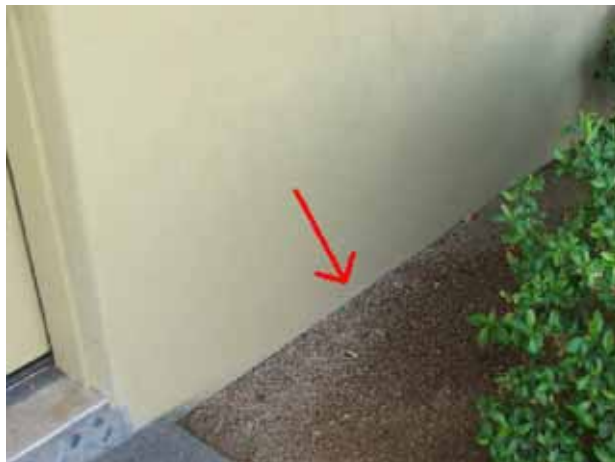
Wall Covering \ Cladding - Stucco\Synthetic Stucco, Stucco To Soil

Stucco in contact with the ground in the back yard.
Recommend a minimum of a 4 inch gap between the bottom of the stucco and the finished grade. Stucco need to be able to drain moisture out of the walls through the bottom of the stucco and termites and other pests may enter the home undetected if this distance is not maintained.
Cracks in stucco are mostly cosmetic and rather common in the phoenix area but they should be monitored and patched when convenient or immediately when any sign of a leak develops.
Recommend patching all stucco cracks 1/16 of an inch or larger as soon as they are found.

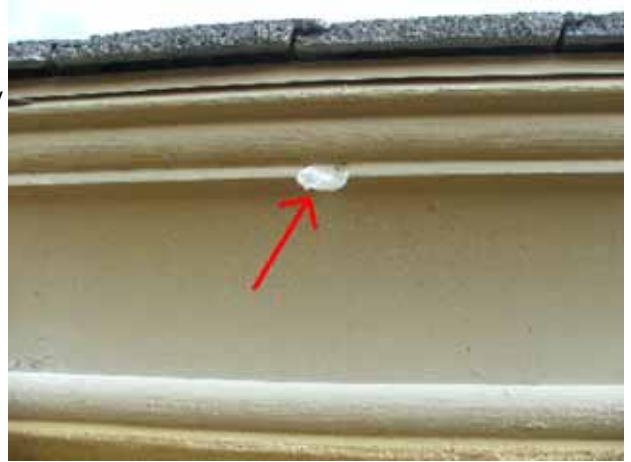
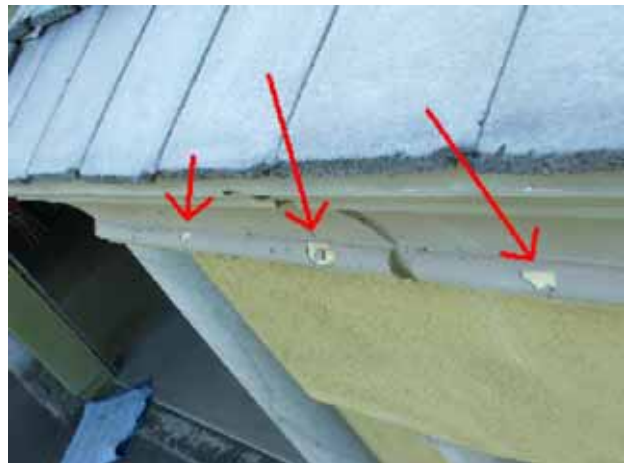
Service/Repair **Soffit\Eaves\Fascia - Other**

The fascia is a foam material covered with a thin coat of plaster. Plaster missing or chipped on the foam fascia at the passage way between the garages and on the back of the house.
Recommend a qualified contractor evaluate and make all necessary repairs. See picture

The fascia is a foam material covered with a thin coat of plaster. Plaster missing or chipped on the foam fascia at the passage way between the garages and on the back of the house. Recommend a qualified contractor evaluate and make all necessary repairs. See picture

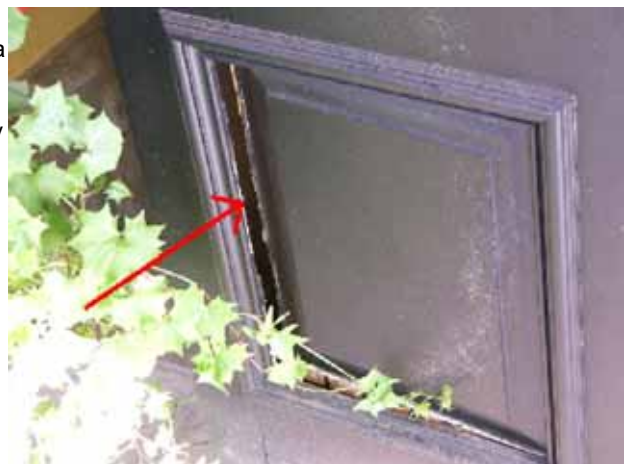
Service/Repair **Exterior Doors - Wood/Imitation wood.**

Exterior entrance door tested and found to be in proper working order. There are cracks in the front door lower panels and there is a loose panel in the built out wall on the left side of the front entrance door.
Recommend a qualified contractor evaluate and make all necessary repairs. See picture

Exterior entrance door tested and found to be in proper working order. There are cracks in the front door lower panels and there is a loose panel in the built out wall on the left side of the front entrance door. Recommend a qualified contractor evaluate and make all necessary repairs. See picture

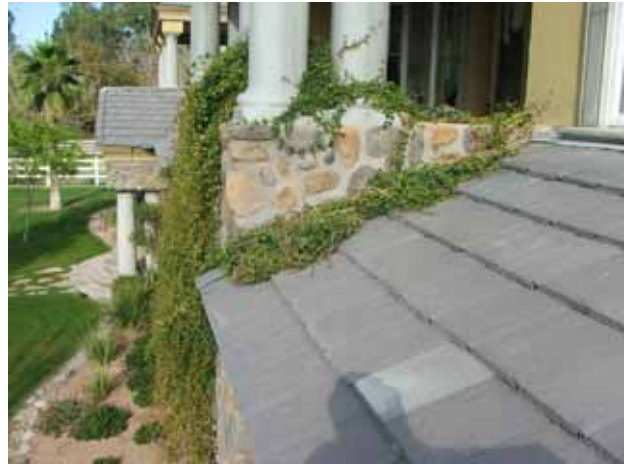
Service/Repair **Vegetation - Checked**

Vines are not good for the house exterior finish or trim. Recommend vines so they do not touch the house or roof.
See Picture

Vines are not good for the house exterior finish or trim. Recommend vines so they do not touch the house or roof. See Picture

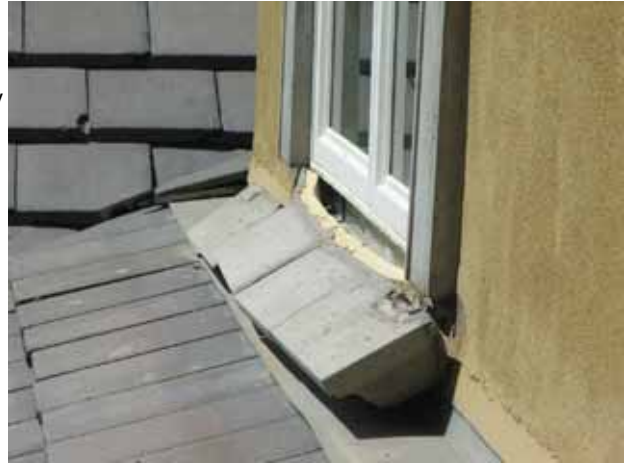
Other - Other

On the front of the house on the 2nd story on the right side of the entrance there is a loose cement window sill that could fall on someone. Recommend a qualified contractor evaluate and make all necessary repairs. See picture

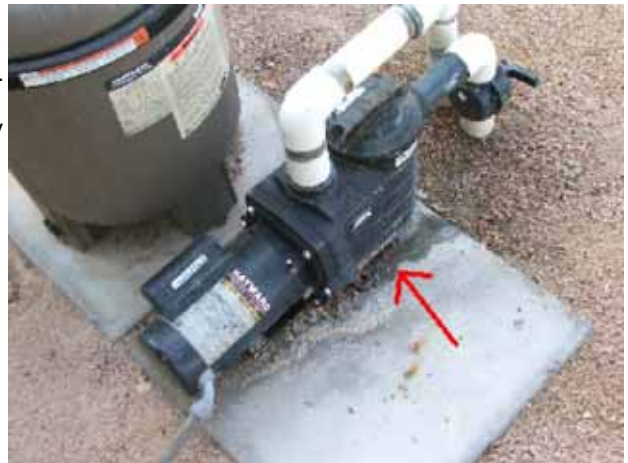
GROUNDNS - General Comment

The front yard water feature pump is not bonded, the pump is leaking, the pipes are not covered or painted to protect them from the sun and there is no safety barrier to keep children from falling in. The auto-fill device did not work when tested.

The front yard water feature pump is not bonded, the pump is leaking, the pipes are not covered or painted to protect them from the sun and there is no safety barrier to keep children from falling in. The auto-fill device did not work when tested. Recommend a qualified contractor evaluate and make all necessary repairs. See picture
This pump has a cartridge filter with a 12 psi reading which is OK.

Recommend a qualified contractor evaluate and make all necessary repairs. See picture
This pump has a cartridge filter with a 12 psi reading which is OK.

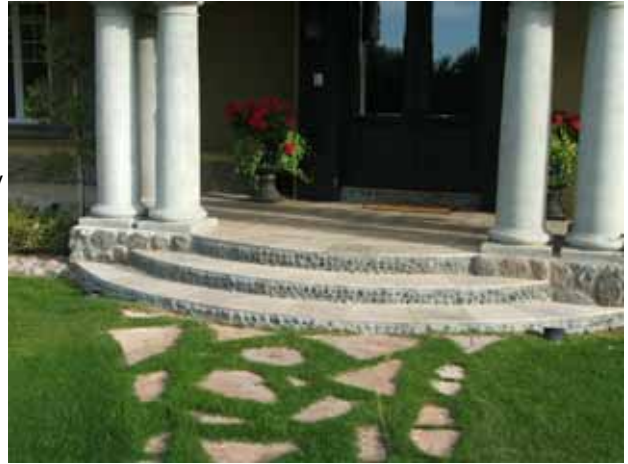
Safety Concern **Outside Steps - Concrete**

No hand rail for any of the exterior steps. Recommend installing handrail to help prevent a fall or trip on the steps. Recommend a qualified contractor evaluate and make all necessary repairs. The front steps vary in height from 4.5" to 6.25". Steps that vary in height over 3/8 of an inch are considered a trip hazard. Recommend a qualified contractor evaluate and make all necessary repairs.

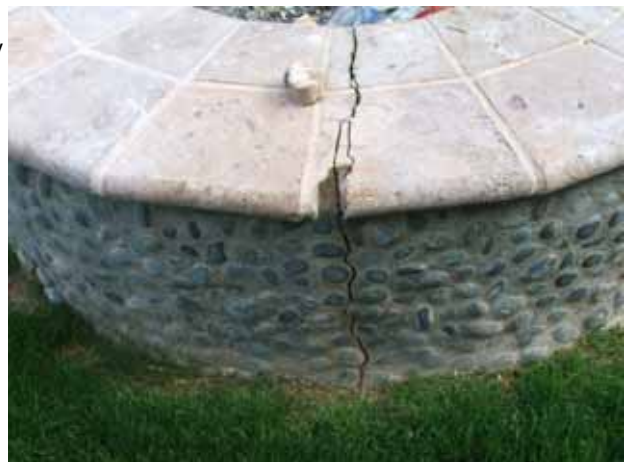
Service/Repair **Stoops / Areaways - Other**

The fire pit in the back yard is cracked in several spots.
Recommend a qualified contractor evaluate and make all necessary repairs. See picture

The fire pit in the back yard is cracked in several spots. Recommend a qualified contractor evaluate and make all necessary repairs. See picture

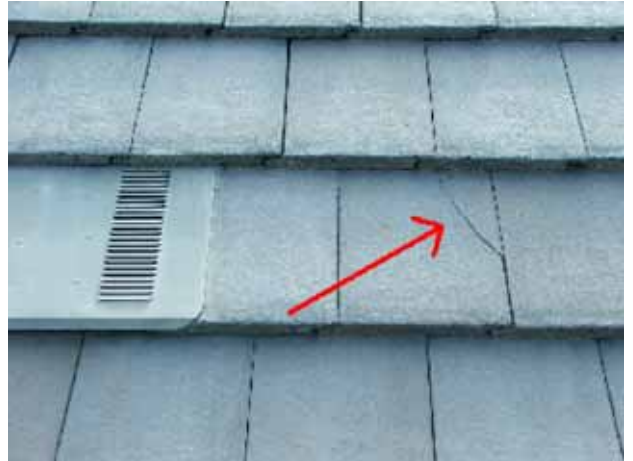
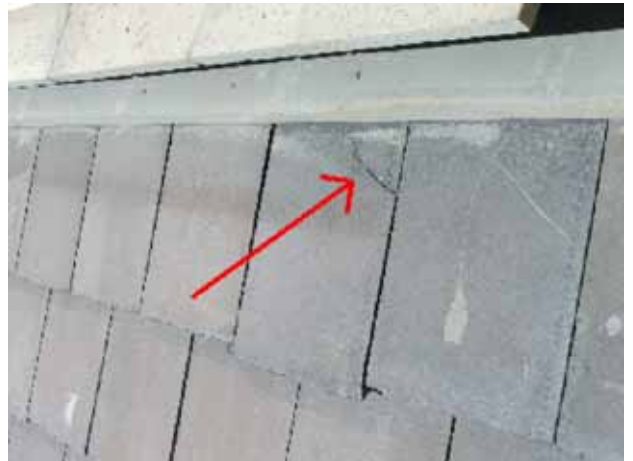
Roof Covering - Tile

Cracked roof tile found on the multi-car garage in the center section facing west on row 5 in 9' from the roof wall.
On the front roof on the east of the porch roof see row 6 in 2 feet from the balcony cracked.
Recommend a qualified licensed roofing contractor evaluate and make all necessary repairs. See sample picture

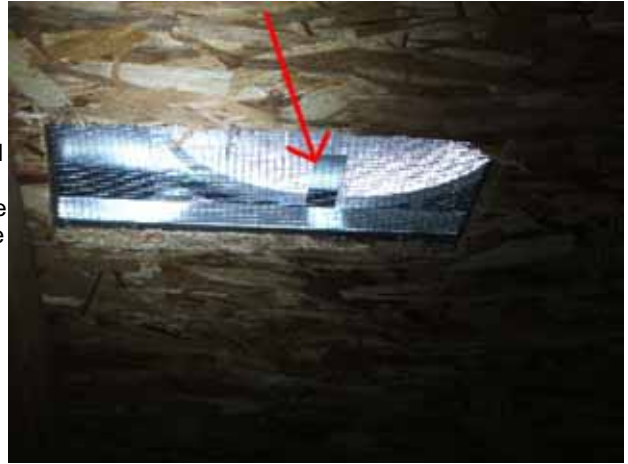
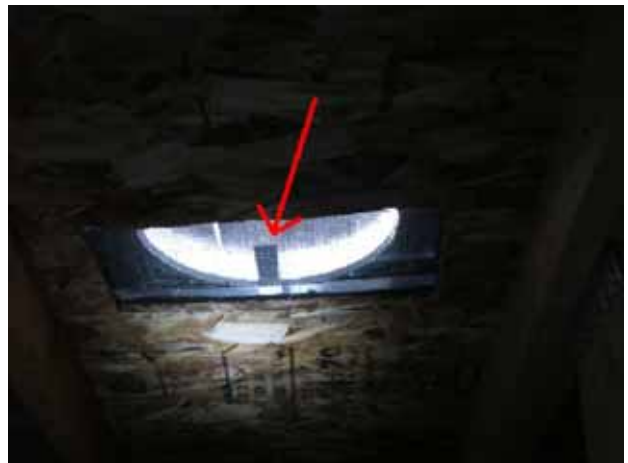
Service/Repair **Roof Vents - O'hagin's**

Wind clips exposed in the roof vents means they are not installed properly under the roof tile. See picture
recommend a qualified roofing contractor evaluate and make all necessary repairs.
O'hagin's roof vents should have a hole in the roof sheathing 19" by 7". The primary flashing should be sealed to the roof paper then nailed 4"oc around the opening. Flashing material should be placed on top of the nailed flange area then the vent cover installed on top with the wind clips under the lower tiles. The vent cover needs to be nailed at the top and all tiles around this hole should be nailed to the roof. Recommend a qualified contractor evaluate and make all necessary repairs.

Wind clips exposed in the roof vents means they are not installed properly under the roof tile. See picture recommend a qualified roofing contractor evaluate and make all necessary repairs. O'hagin's roof vents should have a hole in the roof sheathing 19" by 7". The primary flashing should be sealed to the roof paper then nailed 4"oc around the opening. Flashing material should be placed on top of the nailed flange area then the vent cover installed on top with the wind clips under the lower tiles. The vent cover needs to be nailed at the top and all tiles around this hole should be nailed to the roof. Recommend a qualified contractor evaluate and make all necessary repairs.

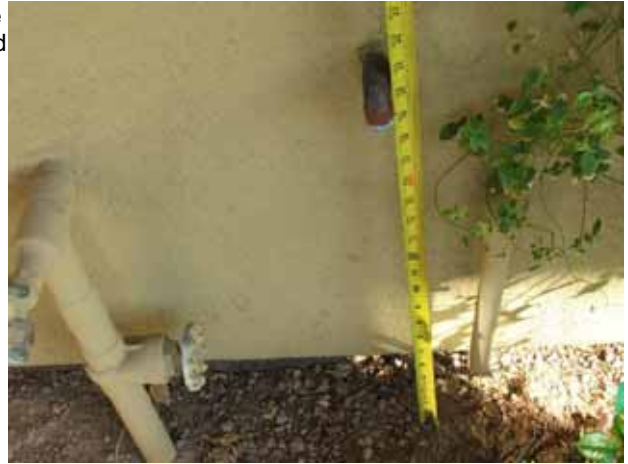
Safety Concern **Temp. Pres Relief Valve and Pipe - Ext Pipe Missing**

Recommend the water heater temperature and pressure relief valve have a pipe extended from the valve to within 6 inches to the ground and point straight down. The current arrangement is a safety issue. Scalding steam can unexpectedly blow out the end of this pipe and the chances of someone getting burned increases the further the pipe gets above the ground.

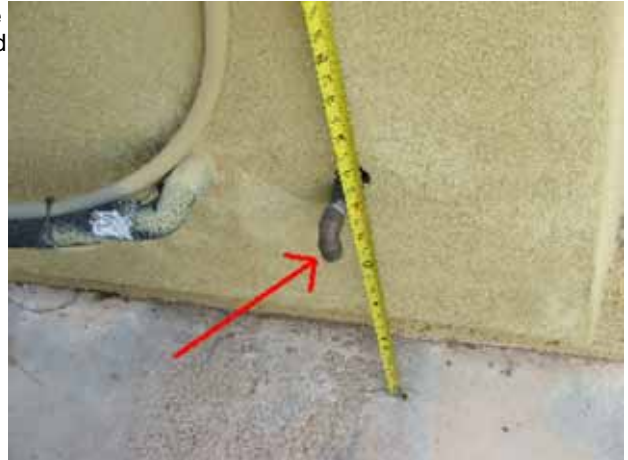
#2Temp. Pres Relief Valve and Pipe - Present

Recommend the water heater temperature and pressure relief valve have a pipe extended from the valve to within 6 inches to the ground and point straight down. The current arrangement is a safety issue. Scalding steam can unexpectedly blow out the end of this pipe and the chances of someone getting burned increases the further the pipe gets above the ground.

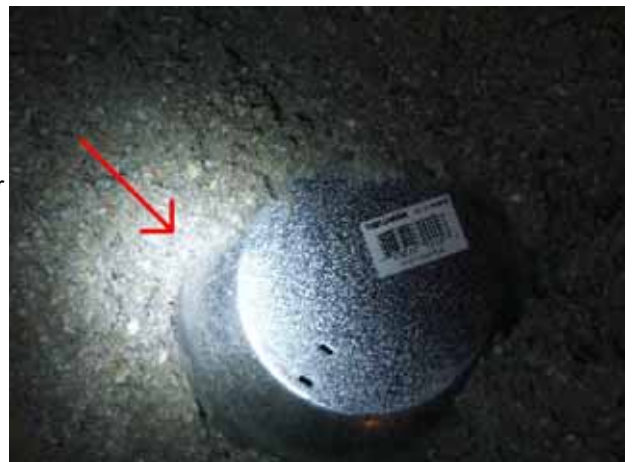
Recessed Light Fixtures - No IC Stamp Found

No IC stamped found on recessed light fixtures in the attic which means the recessed light fixtures may not be approved to have insulation around them in the attic. Some blown in insulation has been known to burn and start house fires when in contact with recessed light fixtures. Recommend finding out if recessed fixtures are IC approved and if not recommend keeping blown in insulation 3" away from these fixtures in the attic to keep the fixtures from over heating.

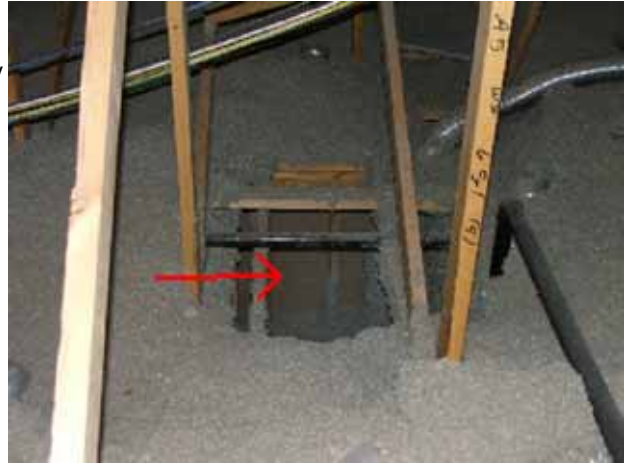
Service/Repair **Attic Other - Other**

Some interior walls exposed to the attic area on the east side of the attic without insulation.
Recommend a qualified contractor evaluate and make all necessary repairs.

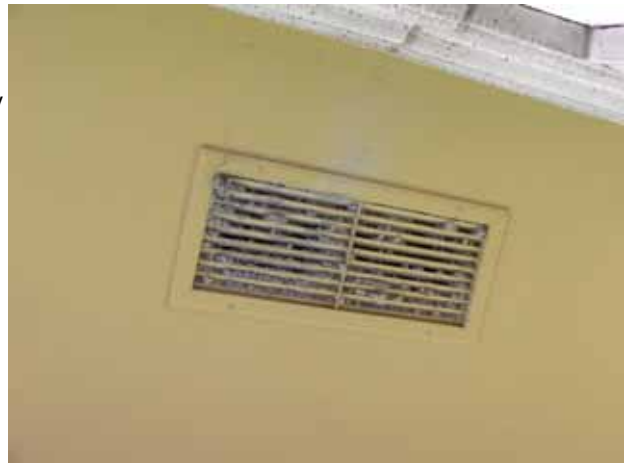
Safety Concern **Dryer Vented - Not Visible**

A vent on the ceiling outside the laundry room is full of lint. This looks like the dryer vent an if so it needs to be cleaned. clogged dryer vents cause house fires. Recommend a qualified contractor evaluate and make all necessary repairs. See picture

A vent on the ceiling outside the laundry room is full of lint. This looks like the dryer vent an if so it needs to be cleaned. clogged dryer vents cause house fires.
Recommend a qualified contractor evaluate and make all necessary repairs. See picture

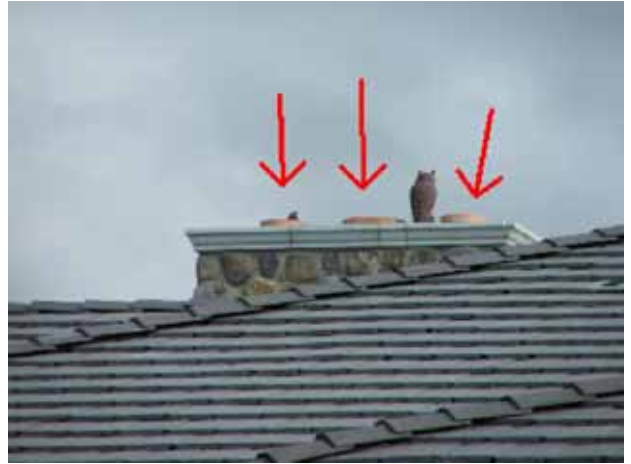
Safety Concern **Spark Arrestor - None**

No screen to cap fireplace which could allow hot sparks to fly out of chimney and may allow pests to enter the chimney. Recommend installing screen on top of chimney.

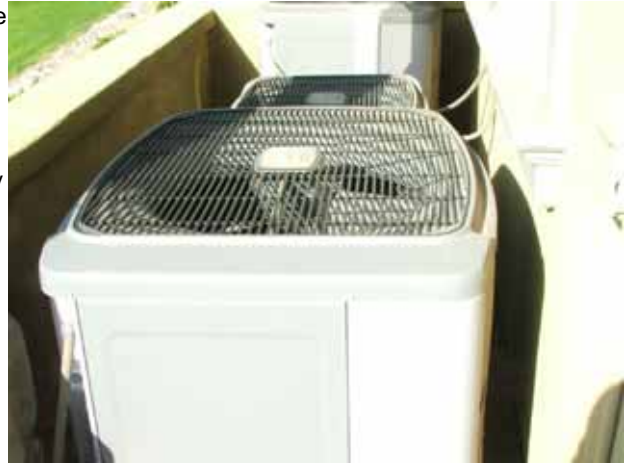
Service/Repair **Cooling System Coils - Split System**

Six split system units with three coils on the east side yard and three in the front yard.
The three AC coils in the front yard are not well spaced apart. Two are within 7 inches of the house wall and close together behind a pony wall. When air circulation is blocked to the AC coils they do not cool as efficiently as they should.
Recommend a qualified contractor evaluate and make all necessary repairs.

The three AC coils in the front yard are not well spaced apart. Two are within 7 inches of the house wall and close together behind a pony wall. When air circulation is blocked to the AC coils they do not cool as efficiently as they should.

Recommend a qualified contractor evaluate and make all necessary repairs.

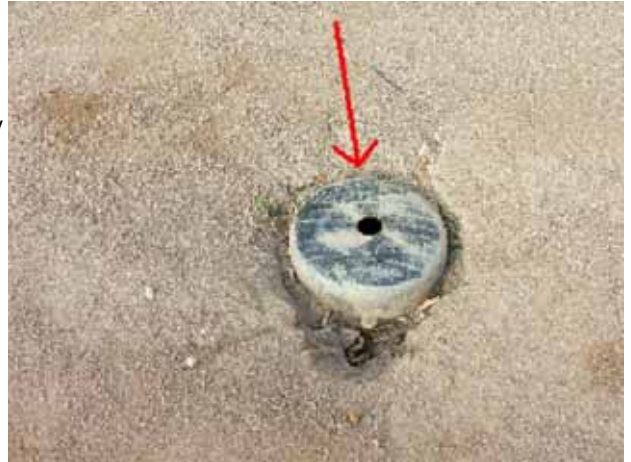
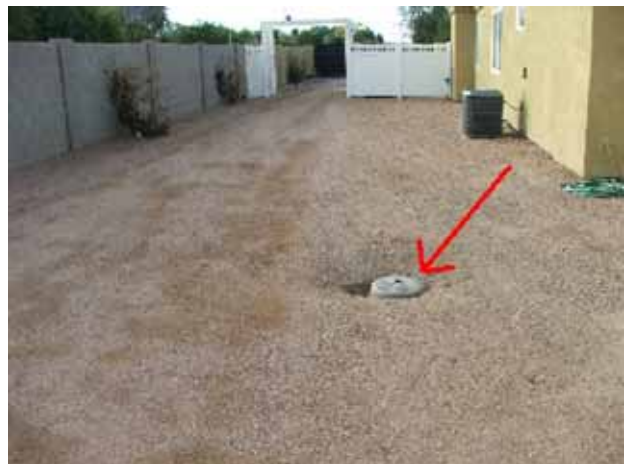
Fuel Supply Tank Type - Other

A gas tank is located in the ground behind the garage. This is not a good location because it is too close to the dirt driveway and there are tire marks on top of the metal lid. Recommend this tank be installed in a location where it will not be run over by vehicles.

A gas tank is located in the ground behind the garage. This is not a good location because it is too close to the dirt driveway and there are tire marks on top of the metal lid. Recommend this tank be installed in a location where it will not be run over by vehicles. Recommend a qualified contractor evaluate and make all necessary repairs.

Recommend a qualified contractor evaluate and make all necessary repairs.

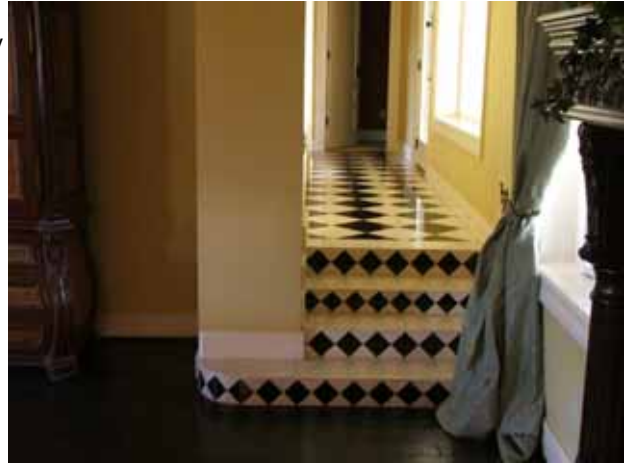
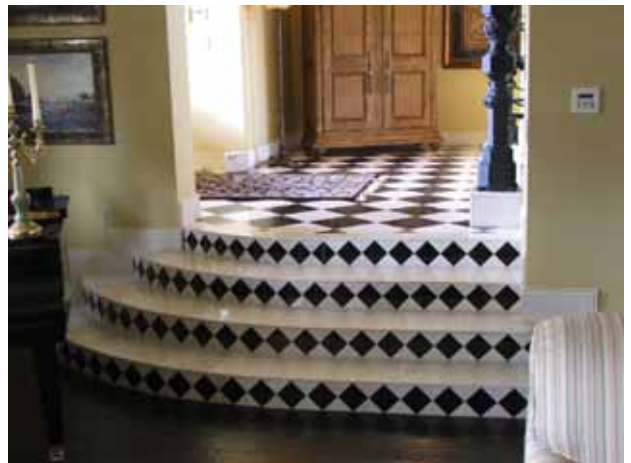
Safety Concern Stairways and Steps - Missing Hand Railings

No hand railing on steps into the living room. This is a trip hazard. Recommend a qualified contractor evaluate and make all necessary repairs. See picture

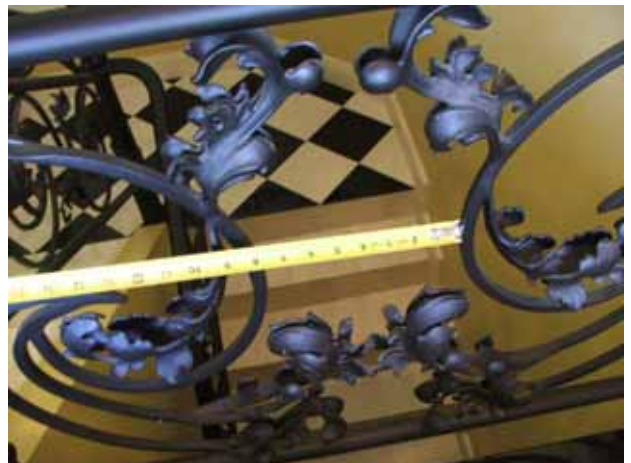
Safety Concern Balconies and Railings - Spacing 4" or More

Railing spacing of more than 4" is considered unsafe for small children. This may have been acceptable when it was built.

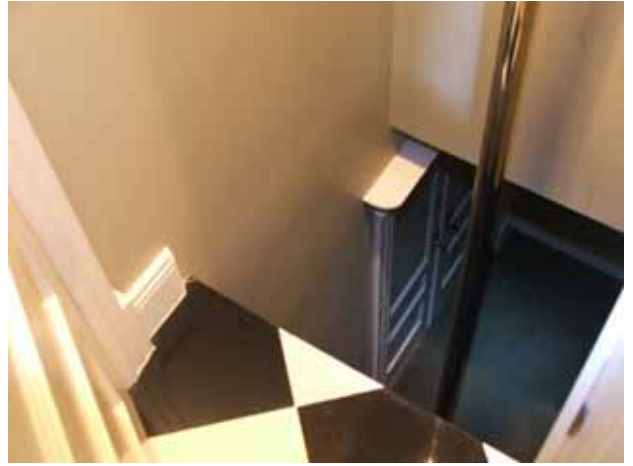
Closets - Other

There is a closet with a pole to the basement. This is a fall hazard. Recommend installing a lock on this door a minimum of 54 inches above the floor so children cannot accidentally open this door and fall to the basement.

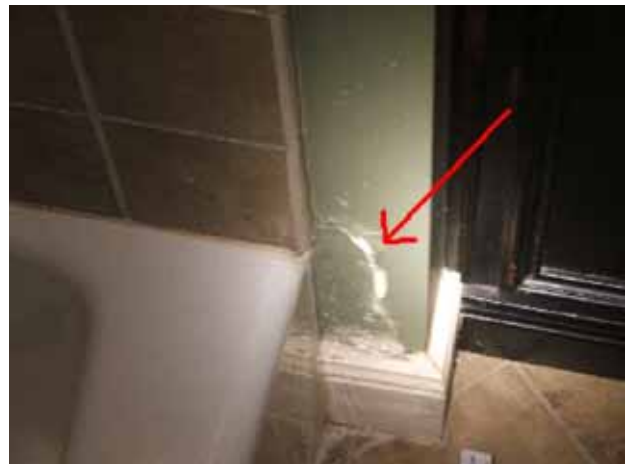
Walls and Ceiling - Drywall/Plaster

Water damage to the wall next to the shower.

Water damage to the wall next to the shower.
Recommend solving problem and then have a qualified contractor evaluate and make all necessary repairs. See picture

Recommend solving problem and then have a qualified contractor evaluate and make all necessary repairs. See picture

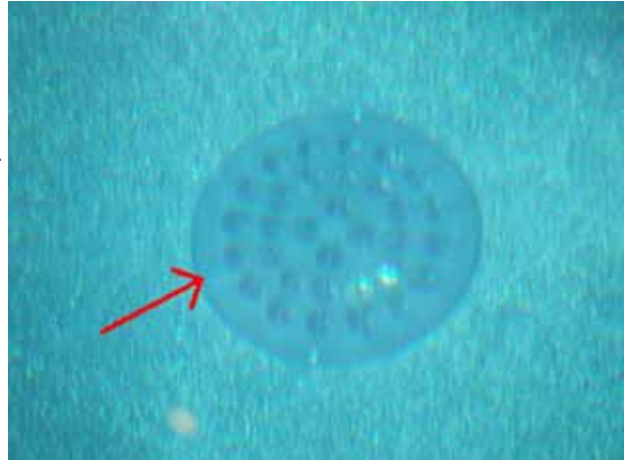
Deep End Drain Diverter - Only One Drain

Beware this pool has only one deep end drain. One may get stuck to bottom of pool at the drain and drown when the pump is on. Recommend installing a different style of drain cover designed to prevent one from getting stuck to the drain and when resurfacing pool recommend installing an extra drain. Recommend a qualified swimming pool contractor evaluate and make all necessary repairs.

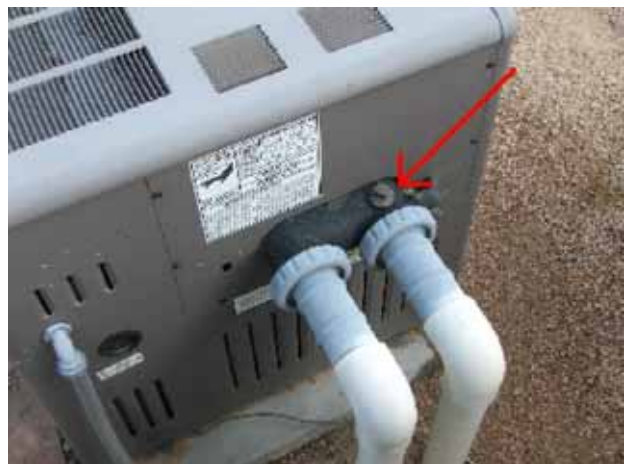
Heater - TPRV

Pool/spa heater tested but no Temperature Pressure Relief Valve installed on pool heater. The heater could explode. Recommend installing a TPRV before using pool heater.

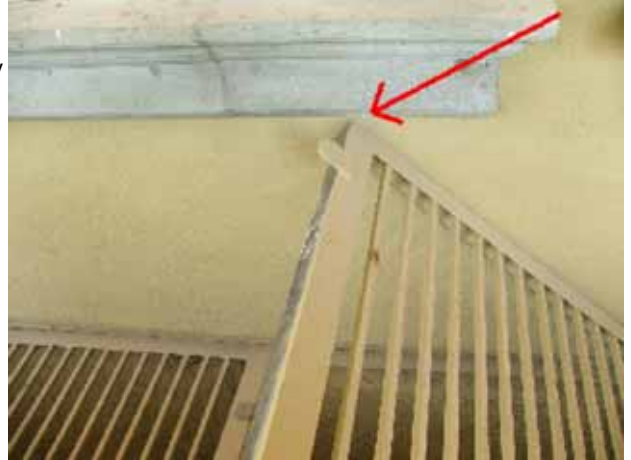
Basement Access - Interior Stairs, Exterior Stairs

The metal hatch to the basement stairs on the exterior is partly blocked by a cement window sill. This is a fire escape hazard.
Recommend a qualified contractor evaluate and make all necessary repairs.

The metal hatch to the basement stairs on the exterior is partly blocked by a cement window sill. This is a fire escape hazard. Recommend a qualified contractor evaluate and make all necessary repairs.
